Test Report

No.: CANIN25007826801

Sample Name: laminate floor

Formaldehyde Emission

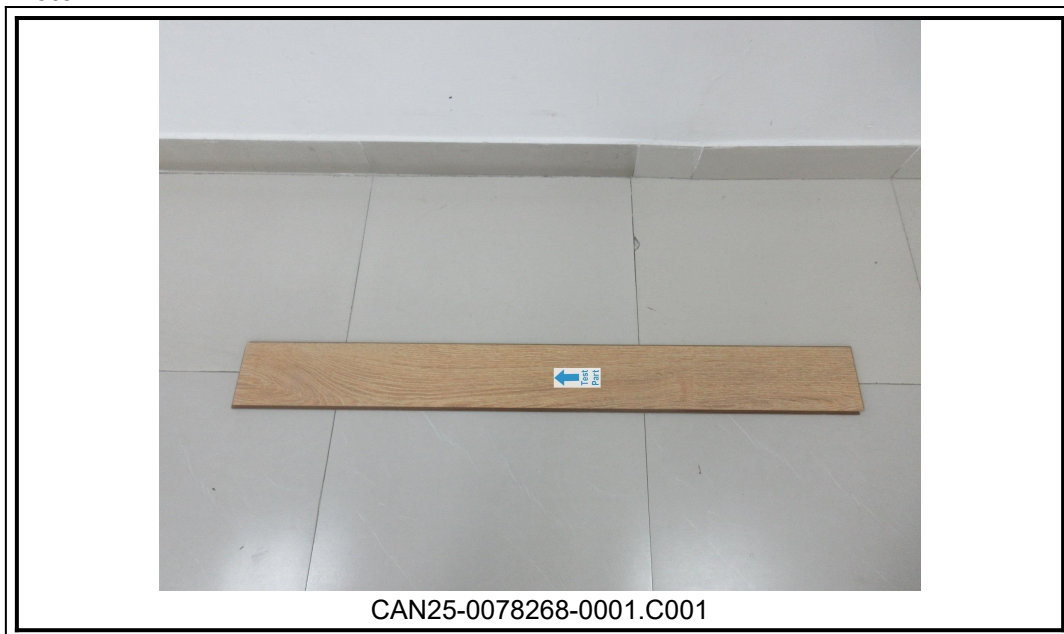
Sample Photo:

SN ID	Sample No.	SGS Sample ID	Description
SN1	001	CAN25-0078268-0001.C001	"lamine floor"
