TEST REPORT

No. : XMIN2504000731CM03_EN

Sample Name : Laminate Floor
Other Information : Importer: Floor Fort (Флор Форт)

Test Item: Thermal Conductivity and Thermal Resistance

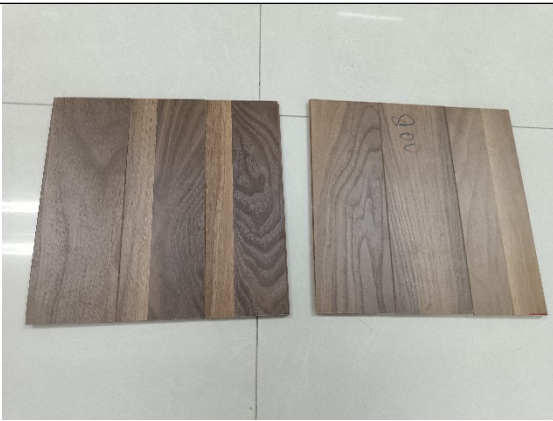
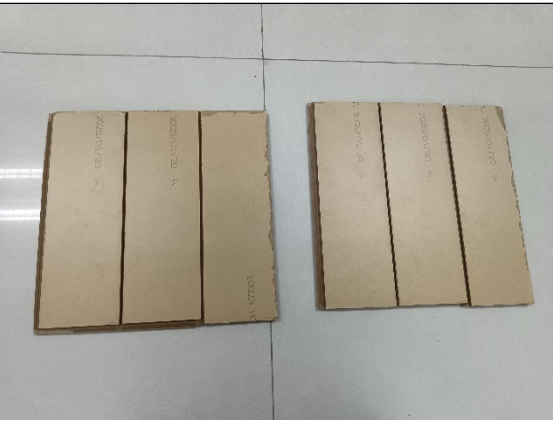
Specimen Photo(s):

Specimen: 300mm×300mm×10.2mm,2pcs

<p>This Surface Contacts with Hot Plate</p>	<p>This Surface Contacts with Cold Plate</p>

1. The test result can not be compared with other results obtained from different test conditions, and should not be cited to the use condition directly.
2. Test specimens were cut from original sample which was jointed by three pieces.
3. The thermal resistance is calculated by the formula:
